**Summary of EPA Surface Water Sampling of Select Metals**  
**Results to Date**  
**Gold King Mine Blowout**

August 7, 2015

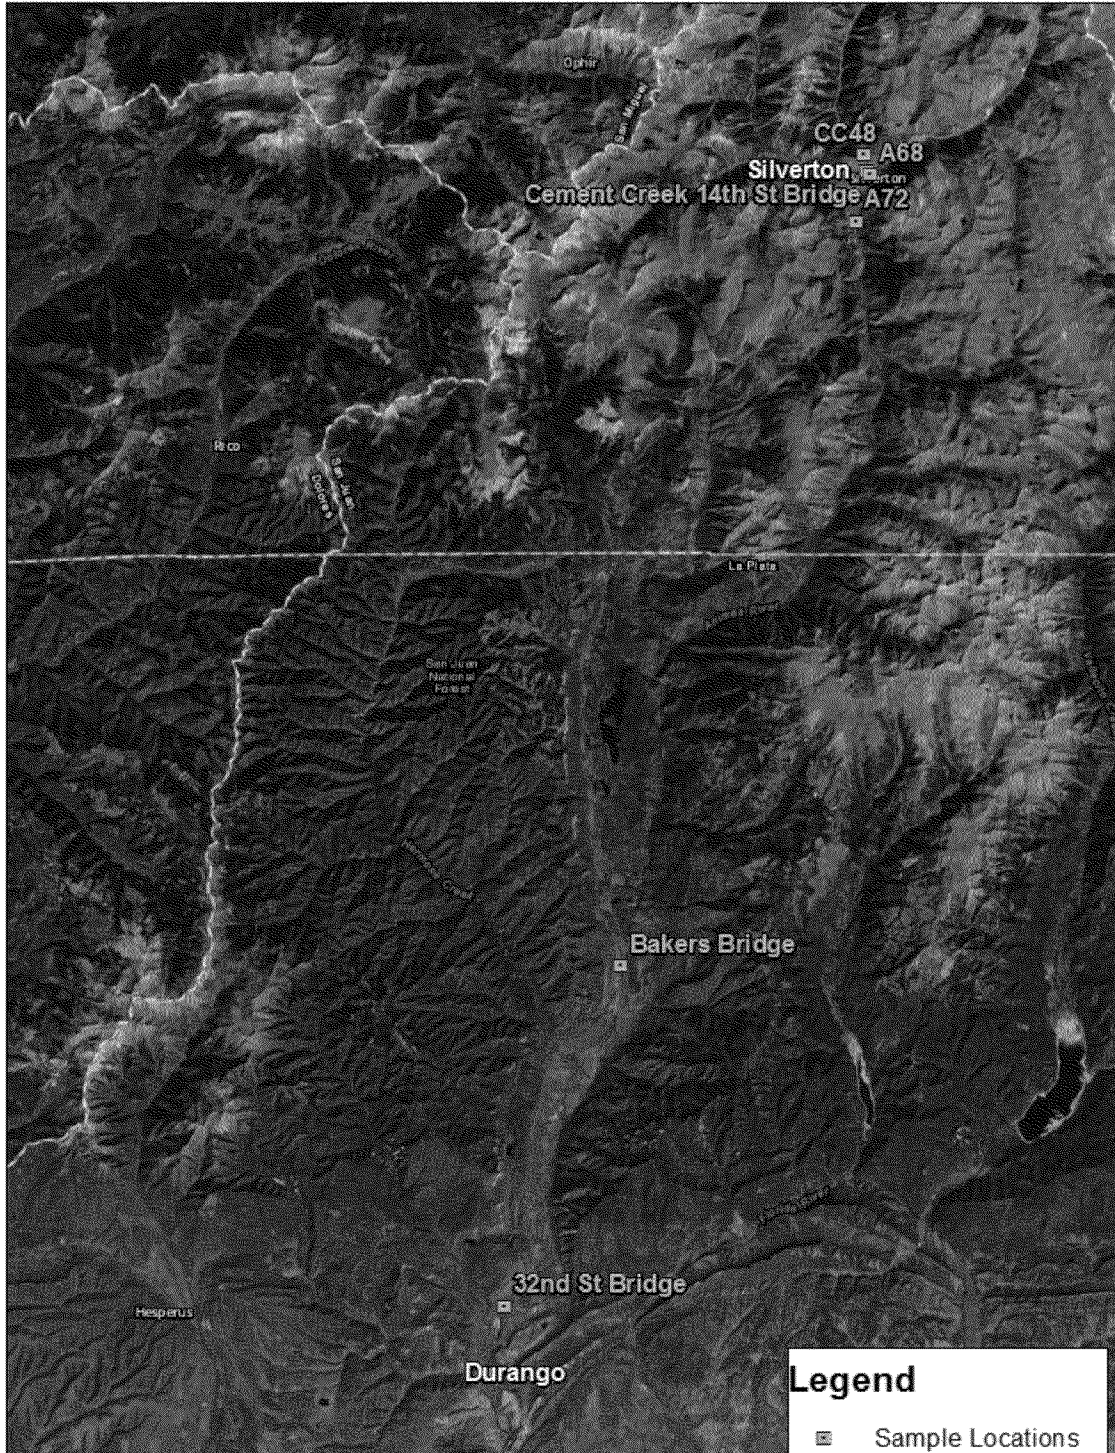
## Attachment 1: EPA Sampling Locations

EPA initiated a sampling effort on August 5, 2015, to assess the impacts of the blowout at the Gold King Mine near Silverton, CO. Surface water quality samples were collected from 7 locations (see Attachment 1). Two of these locations were on Cement Creek and 5 of these were on the Animas River in Colorado. These locations were selected based on the fact that an historical dataset already exists at these locations and they will serve thus as good indicators of conditions before, during and after the event. Data depicted are the results of samples collected over two days. These samples were delivered to the lab on August 6<sup>th</sup>. Results were available and evaluated on August 7<sup>th</sup>.

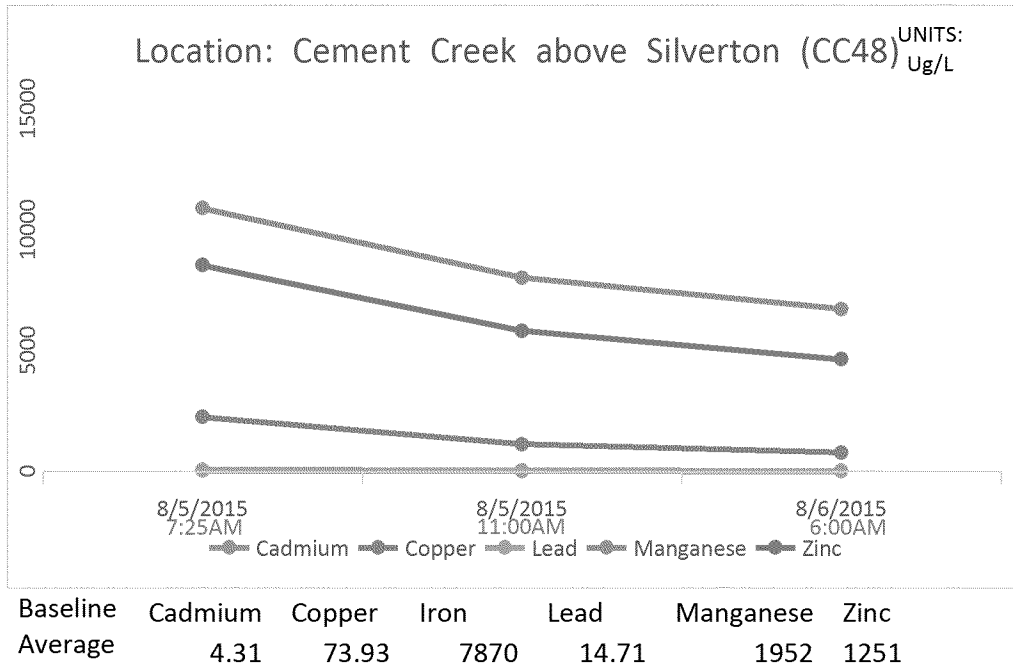
The first graph provides data on Cement Creek, the downstream from the blowout (CC48). Concentrations throughout the first day following the blowout are above historical averages for the copper, lead and manganese. However, the graphs demonstrate a decrease in those concentrations over the 24 hour period.

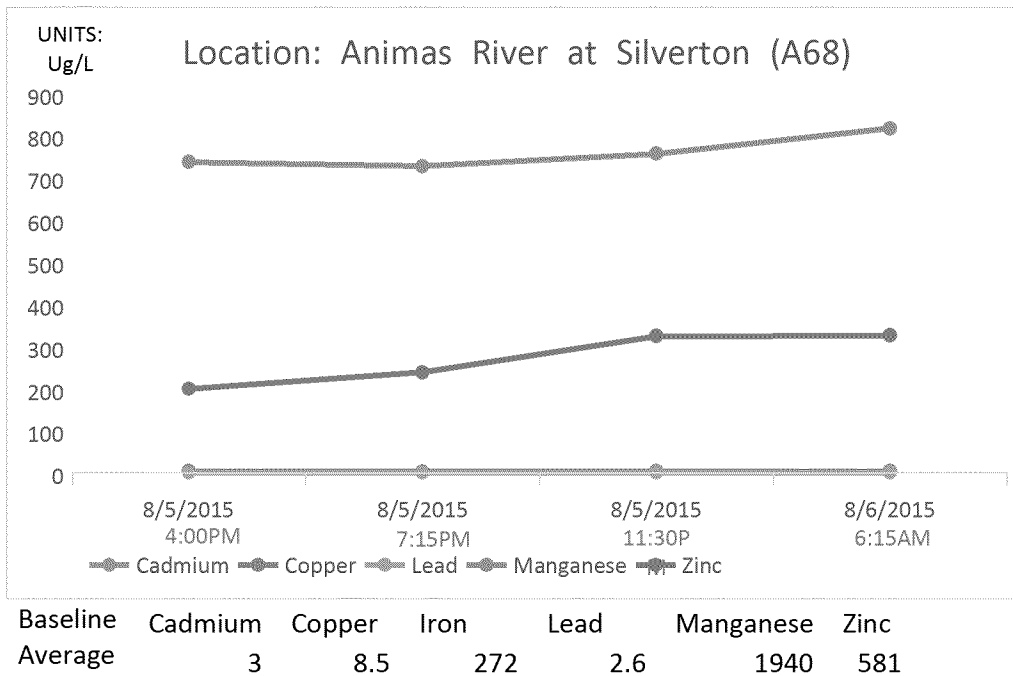
The second graph provides data on the Animas River above the town of Silverton (A68) and above Cement Creek. This graph demonstrates relatively unchanging metals concentrations that are at or below historical averages.

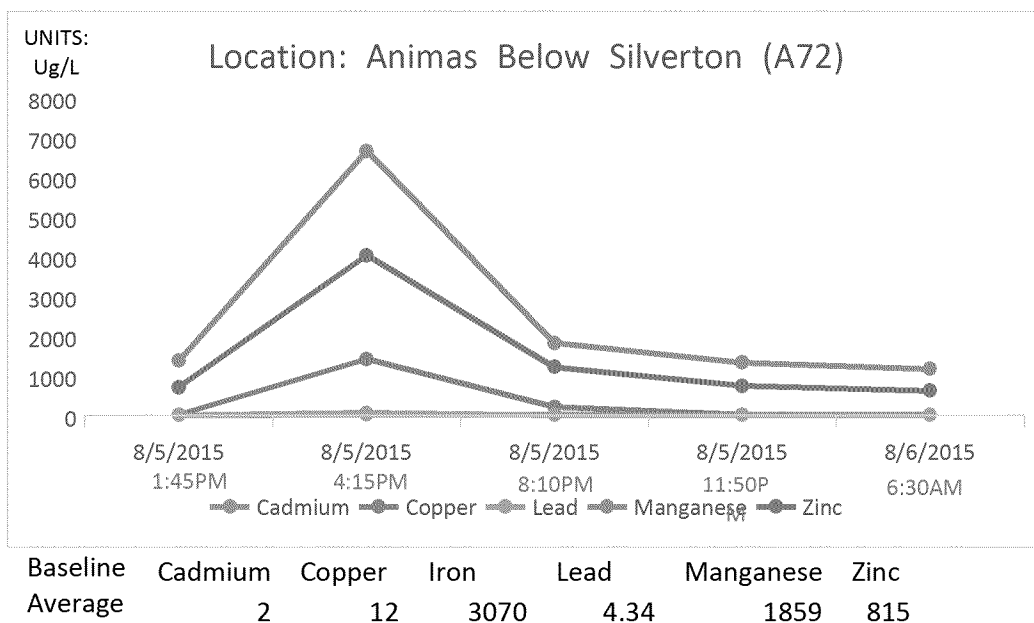
The third graph demonstrates the data from the Animas River just below the town of Silverton (A72). The graph shows an initial spike in metals concentrations with levels returning to historical averages by the morning of August 6, 2015.

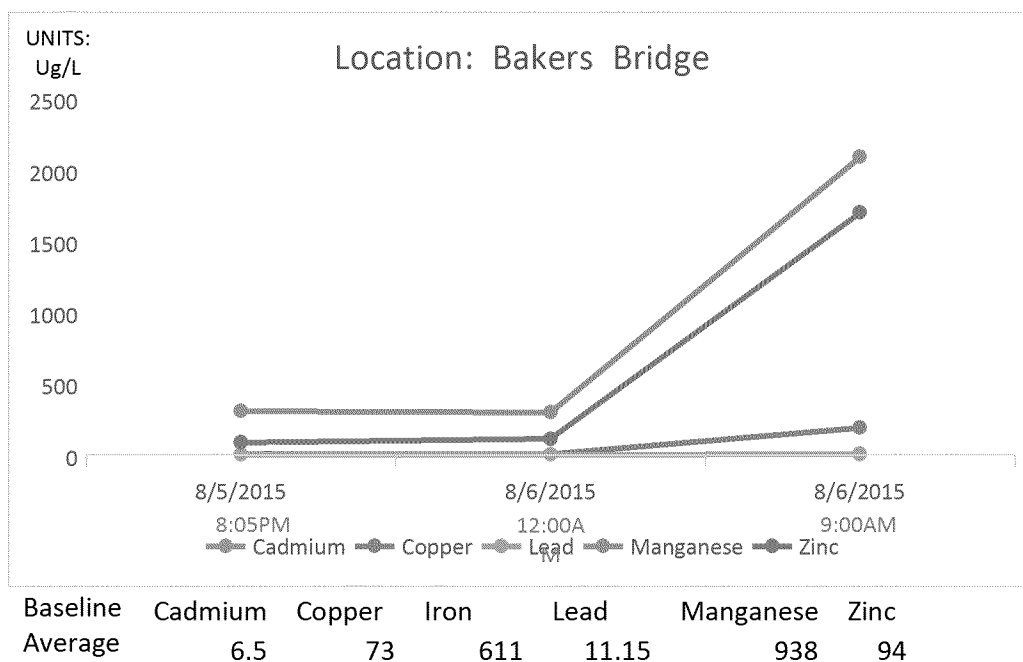
The fourth graph demonstrates the data from Bakers Bridge on the Animas River just above

Durango, CO. Since this location is about 20 miles from Silverton, the metals concentrations are increasing above historical averages. But, it is believed that subsequent data collection activities will demonstrate a decrease in concentrations similar to those seen at upstream locations.

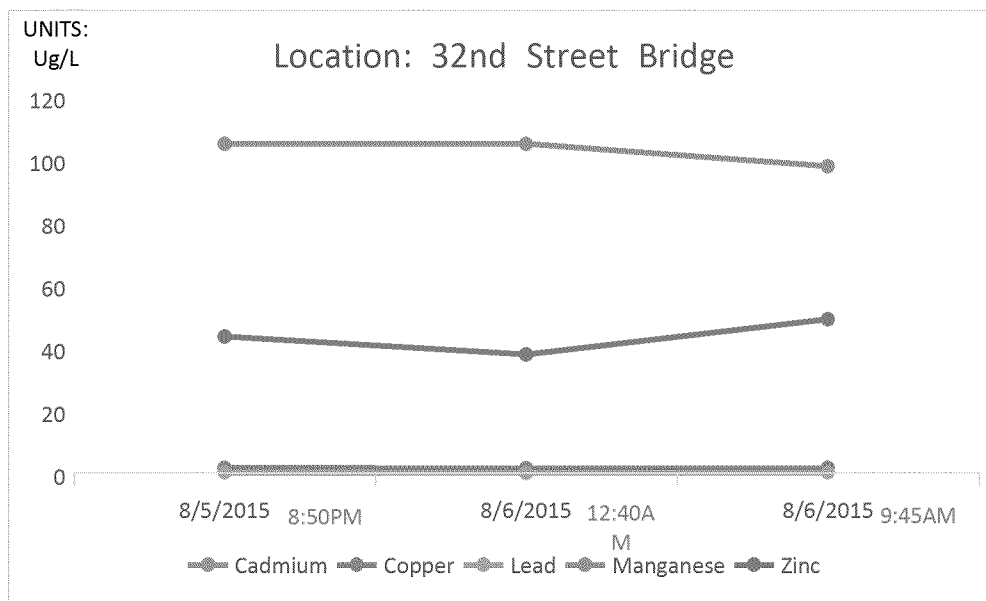
The fifth graph is of the 32<sup>nd</sup> Street Bridge sampling location. At the time the samples were collected, it does not appear that the contamination had yet reached this sampling location.
